CENTRAL INTELLIGENCE AGENCY
INFORMATION REPORT

COUNTRY **USSR**REPORT SUBJECT **Port and Harbor Facilities at Mezen**PLACE ACQUIRED

1. Mezen is a lumber exporting port. The only modern equipment noticed was US-made "Ross Carriers," for the handling of lumber. Two pontoon wharves, one under construction, located at ~~Kamenka~~, about four miles north of Mezen. No storage or warehouse facilities. A Port "Commissioner" handles all business dealings and is in charge of port security. A large amount of air activity noted in area. Lumber for export brought to Mezen by barge from hinterland.

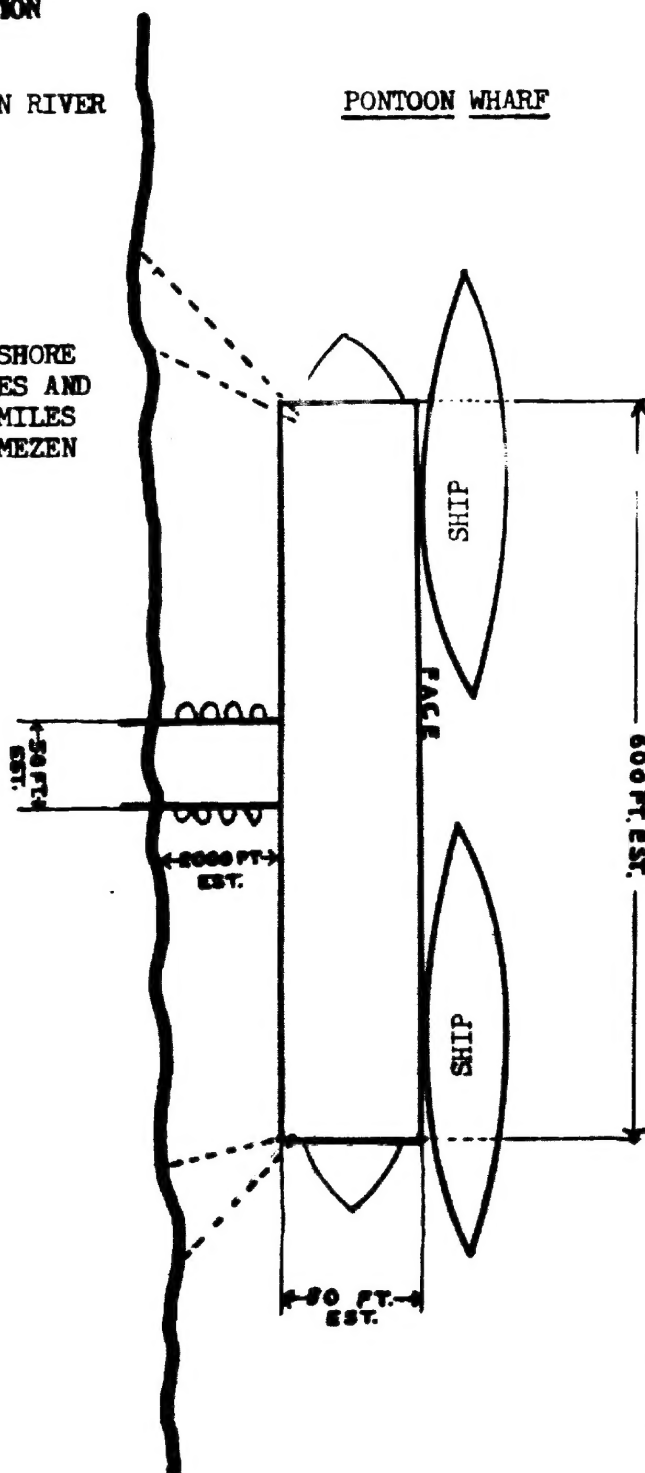
PONTOON WHARF

WEST BANK OF MEZEN RIVER

WHARF SECURED TO SHORE
BY CHAIN AND CABLES AND
LOCATED ABOUT $4\frac{1}{2}$ MILES
NORTH OF PORT OF MEZEN

There are no permanent quays, piers or docks due to the huge tides, strong currents and ice conditions. The only landing facilities whatsoever consisted of two pontoon wharves secured in a parallel position to the shore by heavy chains and cables. Each wharf can load two ships at one time. These wharves are placed in the water in the spring and taken up in the fall. One wharf was completed and one under construction during the time [redacted] ship was in port.
